CHARACTERIZATION OF 'GAIOLEIRO' BUILDINGS – TYPICAL LISBON MASONRY BUILDINGS

DRAFT VERSION

Simões, A.; Bento, R.

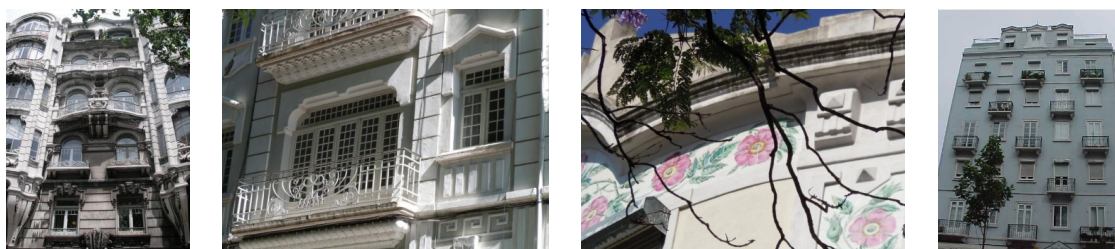
Figure 4 - Decorative details from the front façade wall.

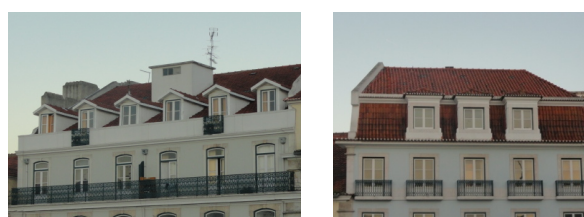
Figure 5 – Dormer and mansard windows.

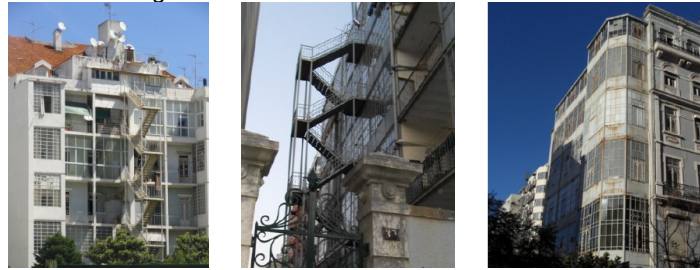
Figure 6 – Metallic service stairs and galleries on 'Gaioleiro' buildings (Andrade, 2011).

The back façade walls are recognized by the metallic balconies or galleries and service staircases to access the interior area of the block, which were actually imposed by the fire-fighters and influenced by the contemporary Iron Architecture (Figure 6).

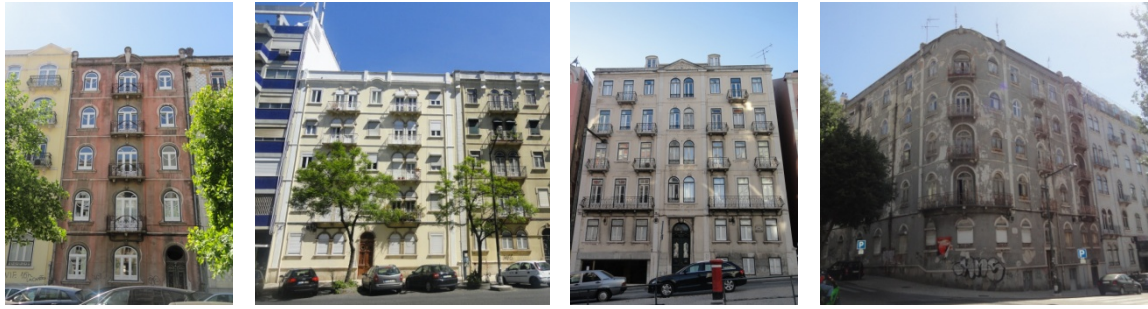
Figure 8 – ‘Gaioleiro’ buildings with different size and shape.

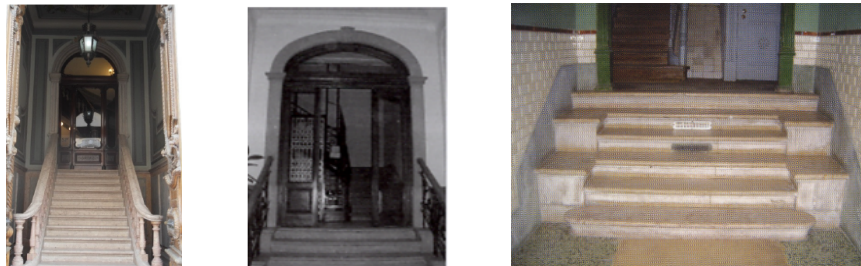
Figure 10 – First flight of masonry staircase gives access to an elevated ground floor with ventilated box underneath (Andrade, 2011 and Appleton, 2005).

The side walls, frequently shared by adjacent buildings, are interrupted by light-shafts, which provide natural light and ventilation to the interior rooms (Figure 9). Ventilated masonry boxes on the ground floor prevented the rising moisture from the soil and the rotten of the interior wooden structures. These can be identified outside by metallic or masonry grids on the façade walls or on the entrance hall of the buildings with a first flight of masonry stairs that makes the connection to the interior timber staircase (Figure 10).

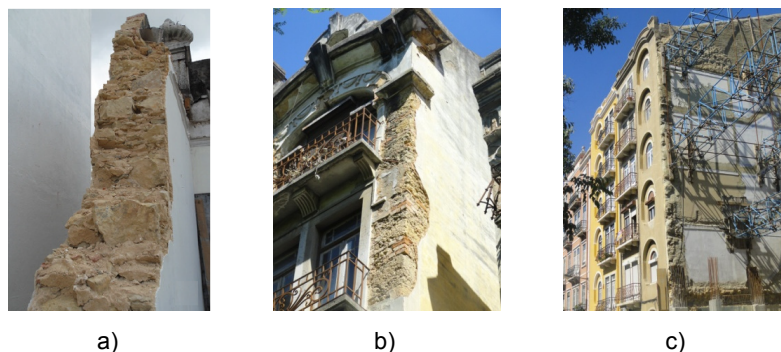
Figure 12 – Exterior Masonry Walls: a) Rubble composition of the masonry side wall (Andrade, 2011); b) Connection between façade and side wall; c) Reduction of the thickness along the height.

The exterior walls were built in rubble stone masonry linked by air lime mortar and sand (in a proportion of 2:1 - Figure 12). The front façade walls are typically 0.60 to 0.80 m thick on the ground floor, with a decreasing thickness with the elevation of the building, resulting in rooftop walls with 0.30 to 0.40 m of thickness (Lopes *et al.*, 2008). The back façade walls were usually 0.50 to 0.60 m thick. Vertical and horizontal timber struts reinforced the masonry walls around door and window openings; although, experience has demonstrated that often these elements do not exist.

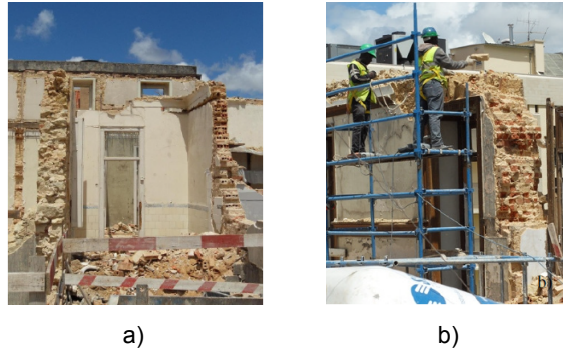
Figure 13 – Brick masonry walls (Andrade, 2011): a) Example of a light-shaft with rubble stone masonry wall (on the left) and solid brick masonry wall (on the right); b) Hollow brick masonry wall.

By the end of the century, new industrial materials were introduced allowing different construction solutions. Therefore, the light-shaft and side walls, originally built in rubble stone masonry, started to be replaced by bricks masonry walls (Figure 13). The wall thickness varies from 0.40 to 0.50 m in the case of the masonry walls or 0.30 to 0.15 m with brick masonry walls, but often constant in height (Appleton, 2005). Nevertheless, the light-shaft walls are usually thinner than the side walls (Figure 13).

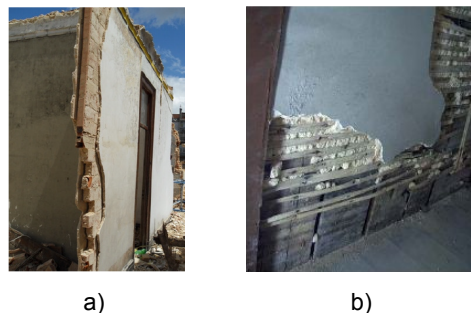
Figure 15 – Interior structure characteristic of 'Gaioleiro' buildings: a) Solid ceramic brick wall (Andrade, 2011); and b) 'Tabique' walls (Pena, 2008).

The 'frontal' walls, composed by a timber truss structure and rubble masonry infill, started to be simplified with the removal of the diagonal elements, conditioning the bracing of the timber frame. The rubble infill was then replaced by brick masonry, solid on the lower floors and hollow on the upper, or by 'tabique' walls, originally used on 'Pombalino' buildings as partition walls (Figure 15).

The 'tabique' walls were made of timber laths nailed to vertical boards, filled on the breaks by rubble masonry, resulting in walls with 0.10 to 0.12 m thickness. Usually these walls were used for room division without a structural role; however, there are some cases where these walls were also supporting the floor beams or used as part of the staircase structure.

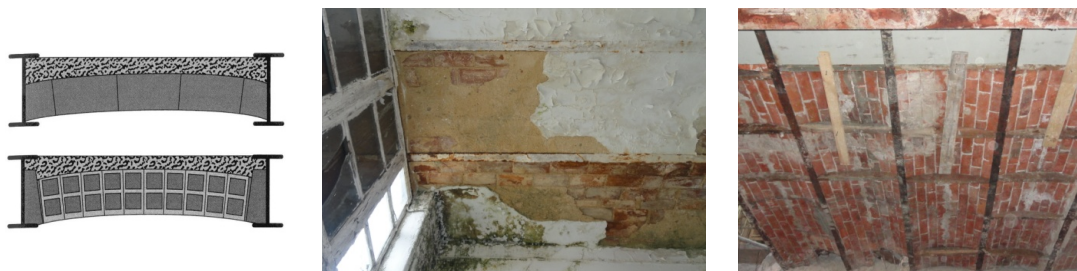
Figure 18 - Floors made of metallic beams and ceramic bricks interconnected by mortar or cement (Appleton, 2005).

The metallic floors were gradually adopted on the kitchen and bathrooms floors. The use of metallic flooring became popular due to the supposed superior durability of iron in relation to wood, especially in areas in contact with water. However, due to the insufficient protection of these elements against corrosion, this solution turned out to be equally vulnerable.

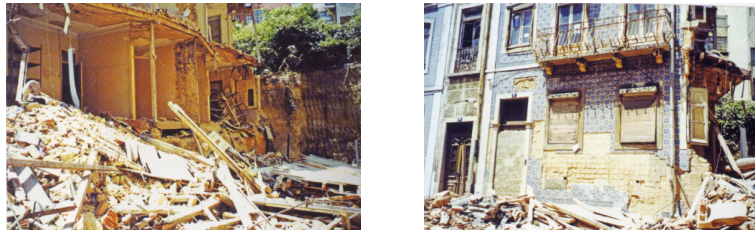
Figure 20 – Collapse of 'Gaioleiro' buildings (Lopes *et al.*, 2008).

Actually, there is the record of a large number of buildings that collapsed even during the construction process (Figure 20).

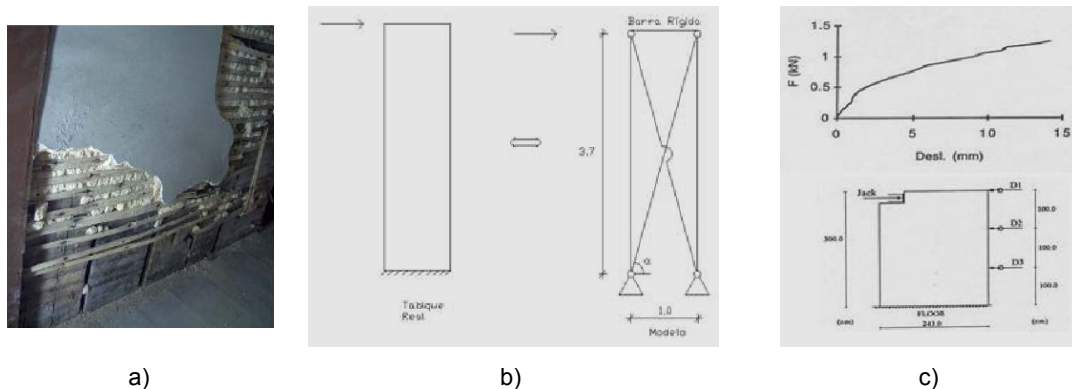
Figure 26 – Numerical Model of 'tabique' walls (Branco, 2007): a) 'Tabique' wall (Pena, 2008); b) Model of the 'tabique' walls; c) Results from the shear test over 'tabique' wall (Lopes and Azevedo, 1997).

Frame elements were adopted to model the 'tabique' walls and the floor beams, since the rigid diaphragm assumption is not admissible. The 'tabique' walls were modelled through a frame structure braced by two diagonal joists. The determination of the elements section was based on the results from the shear failure tests performed on 'tabique' walls by Lopes and Azevedo (1997 - Figure 26).

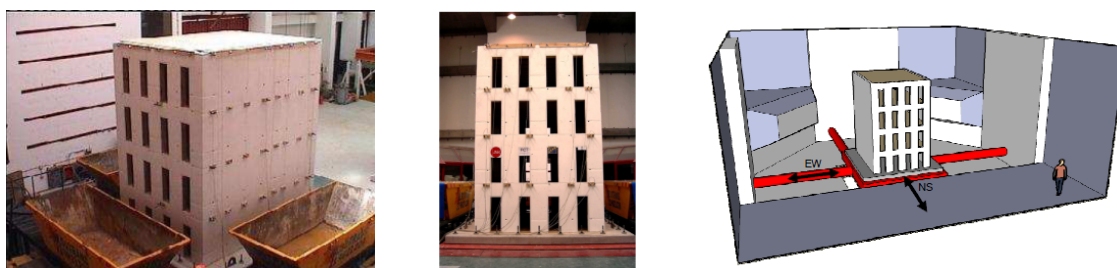
Figure 31 – Overview of the building prototype before test and test setup (Candeias, 2008).

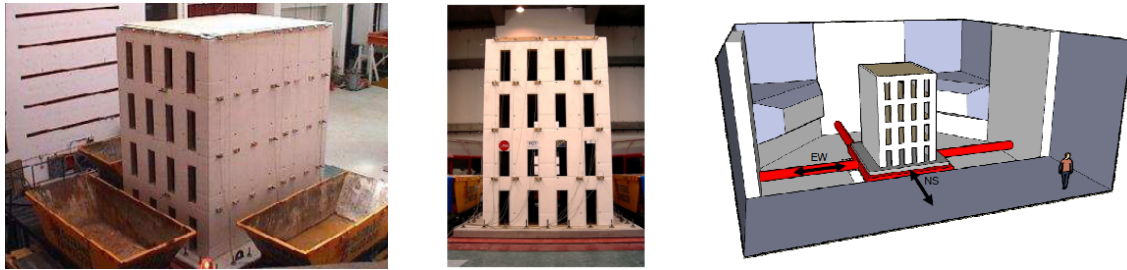
Figure 41 – Overview of the building prototype before test and test setup (Candeias, 2008).

Description: The study considered an experimental campaign developed on 'Laboratório Nacional de Engenharia Civil' (LNEC – National Laboratory of Civil Engineering in Lisbon) considering the seismic vulnerability of 'Gaioleiro' typology of buildings. Five prototypes were built in a reduced scale (1:3) and tested on the LNEC tri-axial shaking table to assess the seismic behaviour of the masonry buildings (Figure 41) and trial the effect of three different reinforcement solutions, represented in Figure 42. Table 15 resumes the main mechanical and geometrical properties of the structural materials and elements of the building.
